Frederikssund Politi

AUV Search in Arresø

Final report, December 2000

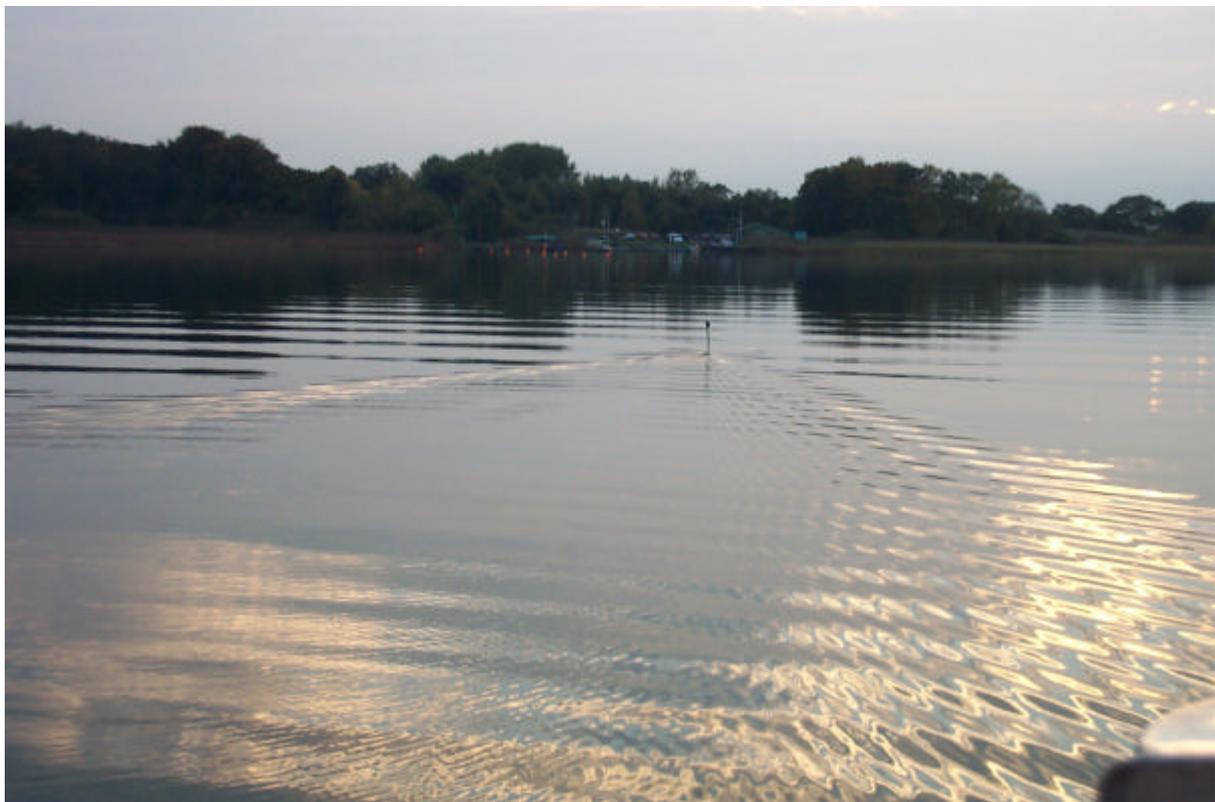
This report describes a search & rescue operation in Arresø, a 40 km² Danish shallow water lake (5 m water depth). The target was a helicopter with 3 man onboard that downed in the lake in October 2000. The search was carried out for the Danish police authorities at Frederikssund.

The survey was carried out using the Maridan M-150 Autonomous Underwater Vehicle equipped with a Tritech 675 kHz side scan sonar (ref. 4).

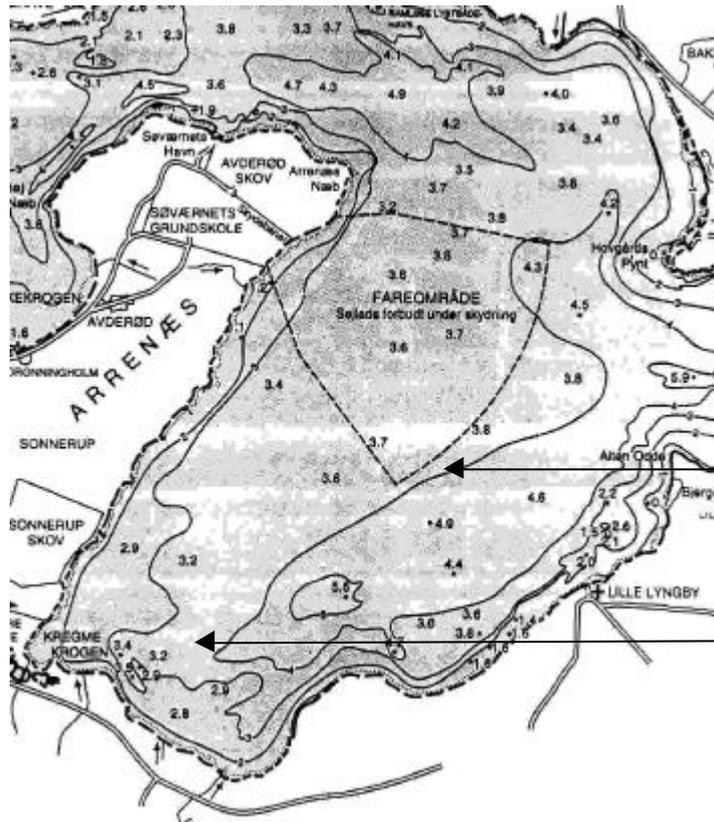
Figure 1: Survey area

The helicopter was found in the centre of the lake (see Annex 1).

The survey started in the southern part of the lake

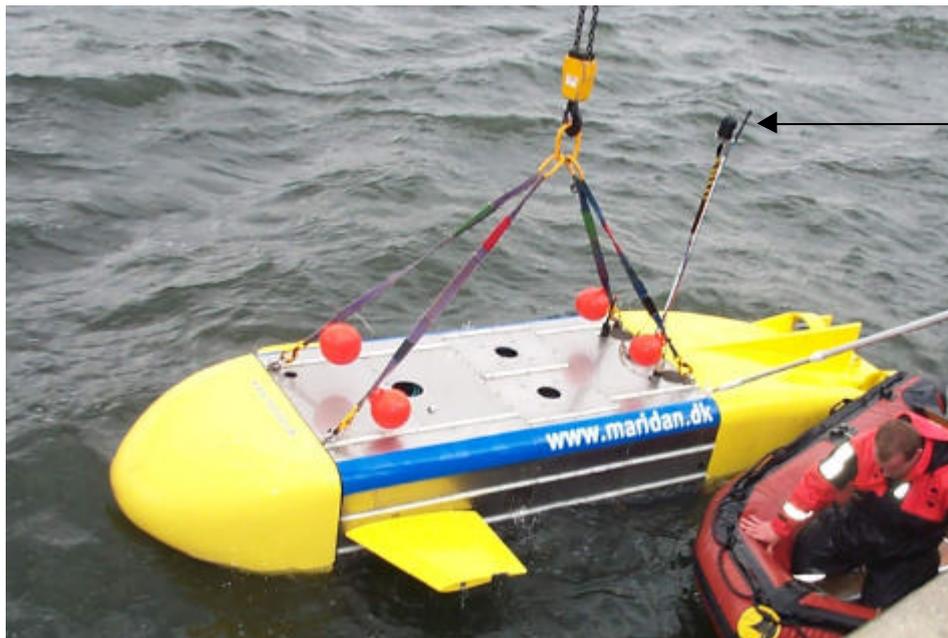
Figure 3: Maridan M-150 Autonomous Underwater Vehicle

→ Raised mast with
GPS, Wireless
Ethernet and Data
Radio antennas

Navigation was performed using the doppler-inertial navigation system (MARPOS, ref 3).

While at the surface the AUV raised its GPS-antenna to initialise the internal navigation system MARPOS and performed accurate apriori calibration of the sensors. Thereafter MARPOS was used as a stand-alone navigation system.

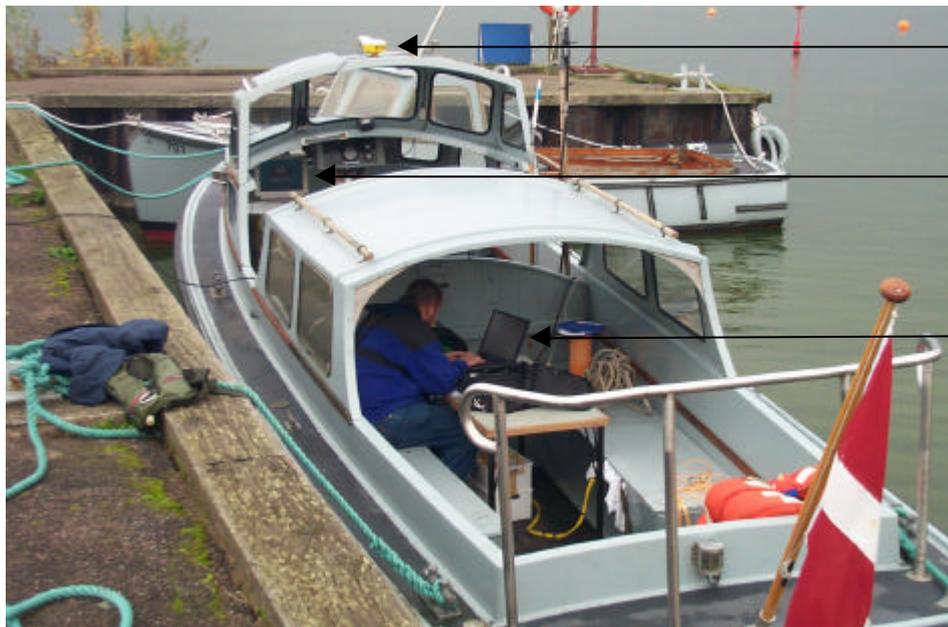
Figure 4: Support vessel for AUV operations

→ DGPS Antenna.

→ Operator PC.

→ PC for Sidescan
sonar display.

The survey was carried out from the Naval Training facility at Auderød, using one of their 9-meter Launches as support vessel for AUV operations. Onboard equipment includes GPS and 2 PCs for operator control and Side scan viewing. Mobilisation time including transport of AUV to location: 2 hours.

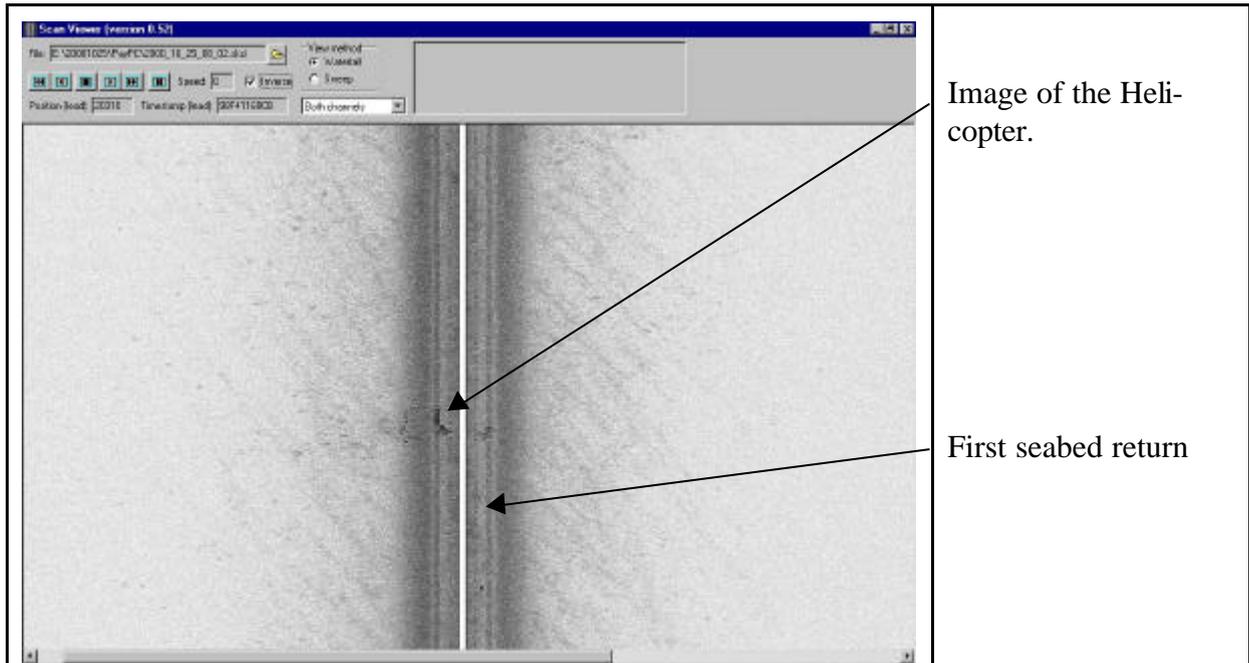
Figure 5: Sidescan sonar image showing the target

Figure 5 shows the sidescan sonar image of the target. The co-ordinates were delivered to the police who confirmed the result by divers next morning: The helicopter was found!

The Sidescan Sonar image of the helicopter does not show very much on the record. This is due to the fact that the AUV passed right over the target. The waterdepth in the area was approximately 4 meters and it can be seen that the target is protruding 1.5m over the seabed.

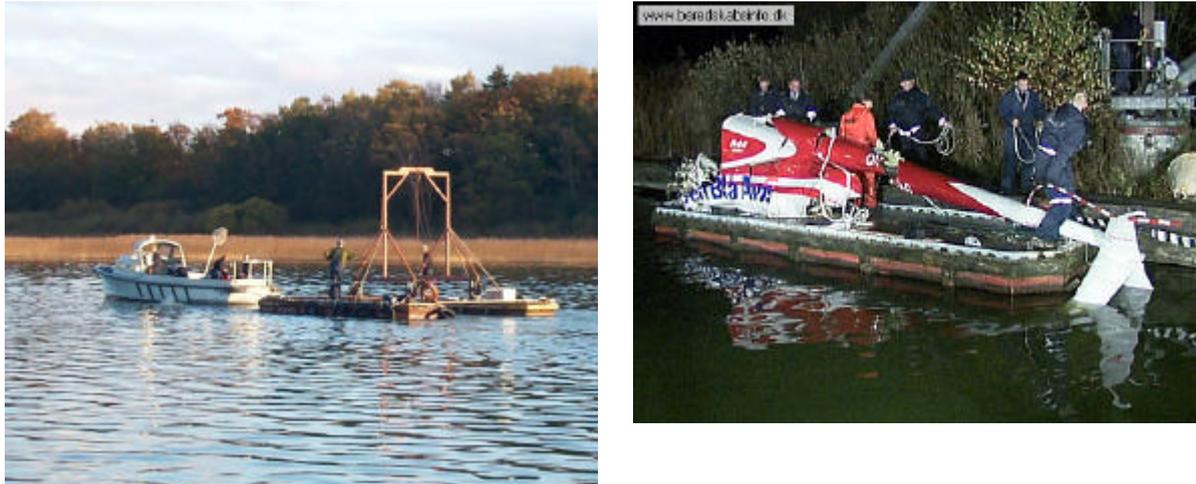
Figure 6: Recovery of the helicopter

The helicopter was recovered 27.10. (Figure 6) but the dead bodies were not inside. A final survey of the target area was carried out using the sidescan sonar in high-resolution mode. No targets were located by this survey. Few weeks later the police found the three bodies at the shore.

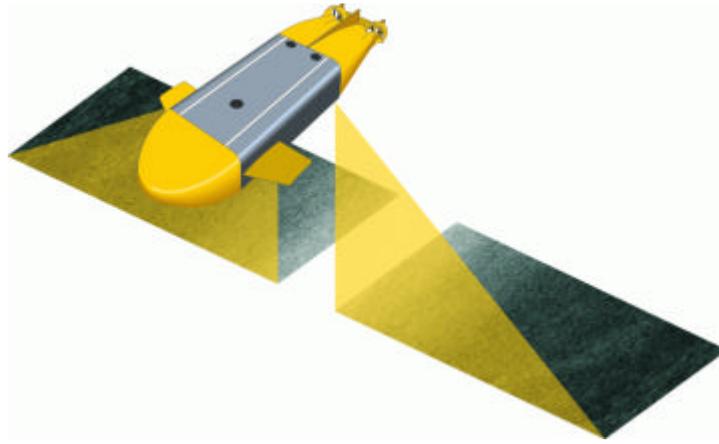
Figure 7: Sidescan sonar, principle of operation

A Sidescan sonar system works as an ultrasonic scanner. Well defined acoustic pings are frequently transmitted from two transducers mounted on each side of the AUV. The signals reflected from the seabed provides information on signal strength and travel time. This information is used to generate an acoustic map of the seabed (Figure 7).

Objects on the seabed will reflect the acoustic energy to the transducer. The strength of the reflected signals indicates the hardness of the objects. The distance to the object can be determined from the travel time and the speed of sound in water (approx 1500 m/s). As the transducer proceeds through the water, repeated regular transmissions generates a continuous image (sonograph) of the covered area. The image is display on computer screen (waterfall) during the survey.

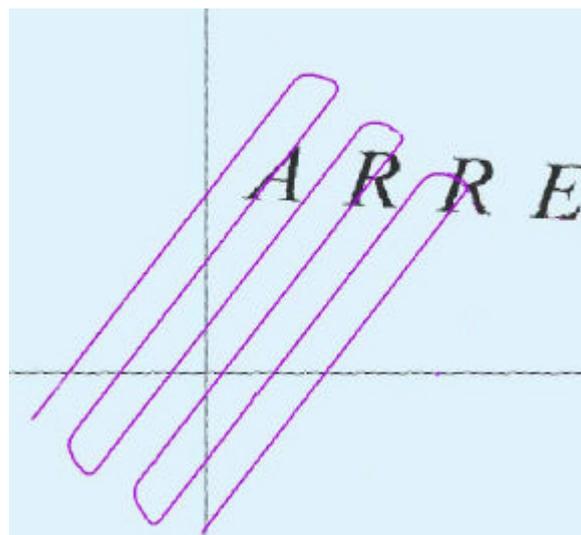
Figure 8: "Lawnmover" pattern, 100 m line spacing

The maximum obtainable range in the shallow lake, was 55 metres either side, whereby a 100m swath was covered with the minimal overlap.

The AUV was programmed to travel in a ‘lawnmover pattern’ with a linespacing of 100m (Figure 8). Typical length of the lines was 1-2 kilometers.
